**Energy Audit and Efficiency Retrofit Report
for**

**First Unitarian Church of Oakland
685 Fourteenth St.
Oakland CA, 94609
510.893.6129**

**Ben Thompson
Peralta Energy Group
Oakland, CA
510.459.0827
PeraltaEnergy.com**

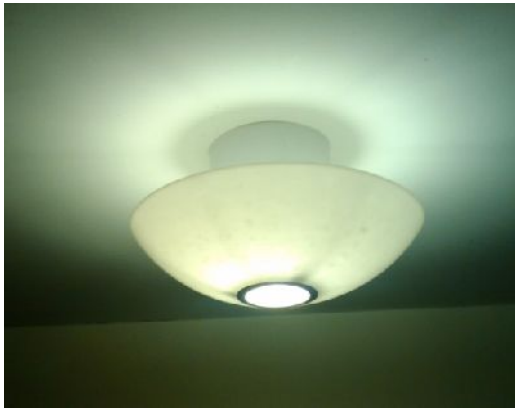
Pendant light fixture with CFL lamp.

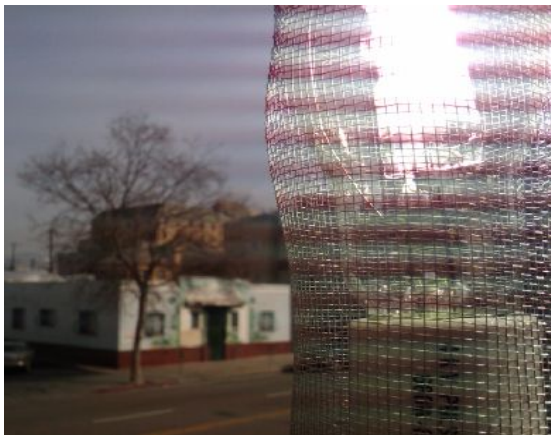
Continuously burning exterior lamp.

The globe lamps on the front patio were found to be in continuous (24/7) operation. The lighting circuit has not yet been located. Once located, photocell controlled socket adapters should be installed. This negligible cost qualifies this as a 'no-cost' measure.

Select lighting fixtures can be re-lamped with LED lamps. Recommended fixtures include the 'continuously on' restroom lamps; exit signs in Hamilton Hall; exterior ramp lighting; front patio lamp posts. PG&E rebates are available for some fixtures.

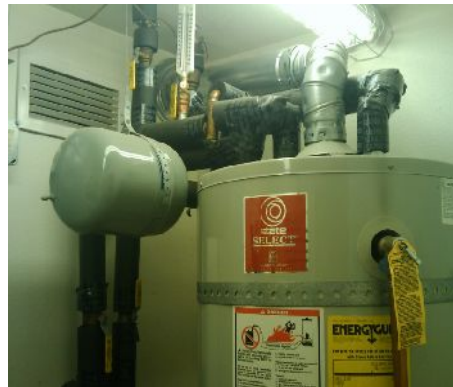
Hot water demand in facility is low. This heater may not be necessary and costs a minimum of \$300/year to operate.

Because hot water demand in the facility is very low, serious consideration should be given to eliminating the conventional gas storage water heater. An under-sink electric 'on-demand' heater can be installed in the kitchen.

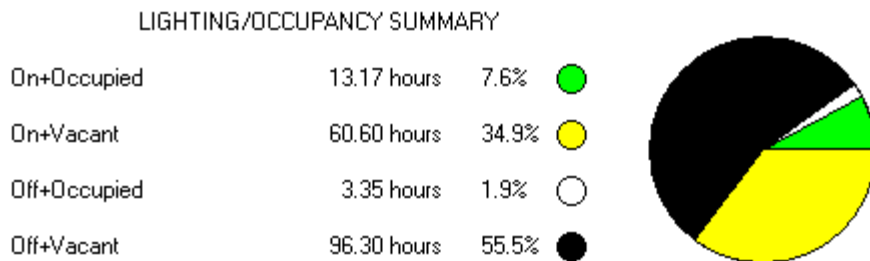
First Floor Hallway. Occupancy sensor recommended..

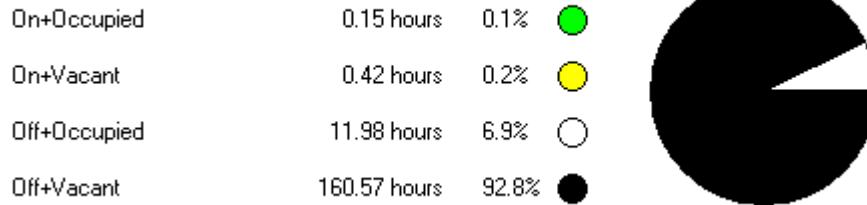
Second floor hallway. Lights used very little. Sensor not recommended.

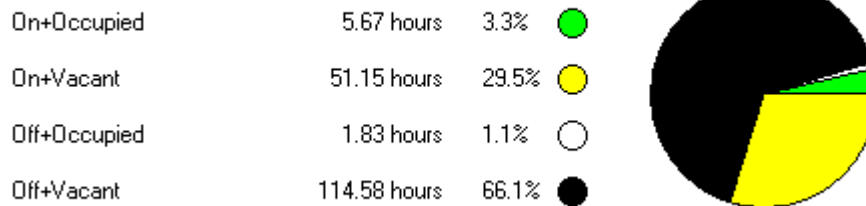
First floor ladies restroom. Occupancy sensor recommended.

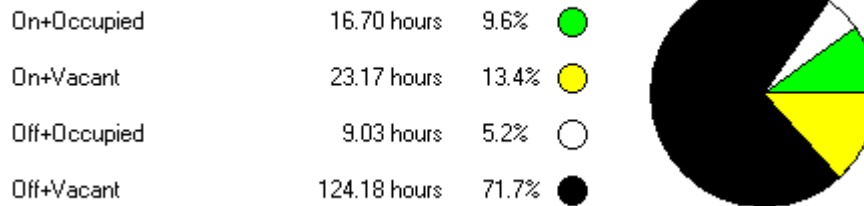
Third floor open area. Occupancy sensor recommended.

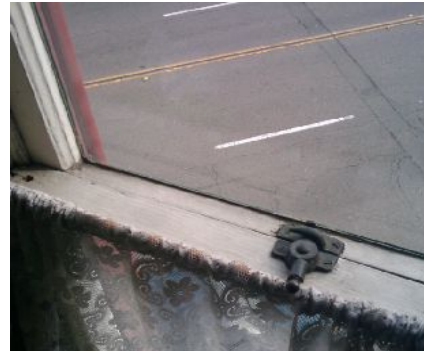
Old double-hung window.

Weather stripping can be installed on select exterior doors such as those to the rear patio. Old double hung windows can be weather stripped where the upper and lower sash meet. Windows that are never opened can be caulked with rope or silicon caulk. Energy savings from this measure cannot be estimated accurately. Savings are assumed to be 1% of the annual heating season load.
